MANAGING NATURAL LIGHT IN HISTORIC PROPERTIES

David Thickett¹

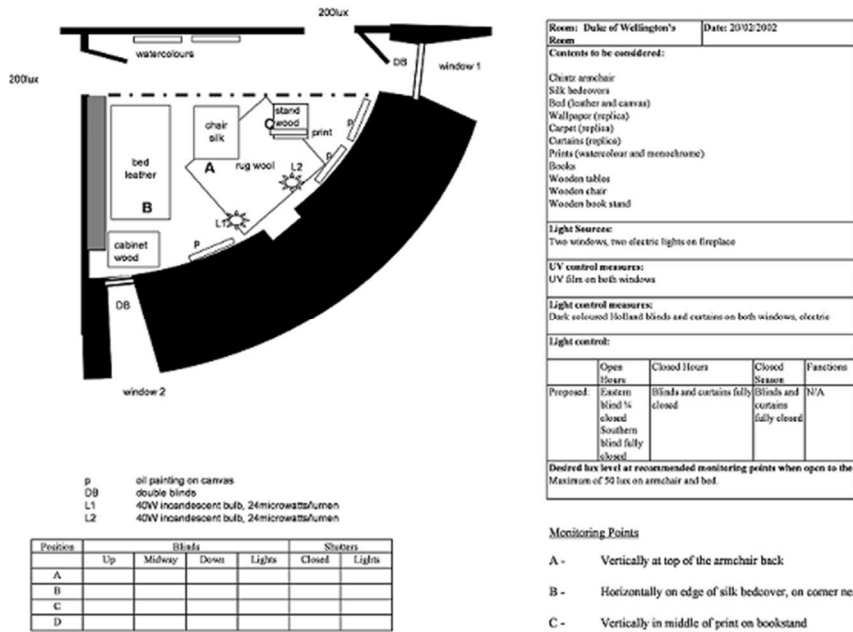
FIG. 1 – Example of a light plan.

Light plans have been developed by several institutions to manage daylight. Essentially, a large number of measurements are taken ideally over several months. These guide the selection of measurement points that are then used to manually adjust the blinds and any artificial lights present to achieve set lux levels. Overall, the objective is to achieve a particular annual dose across a collection in a room. The plans often include indicative blind positions, sometimes for different times of the year and different sky conditions. An example is shown as FIG. 1.

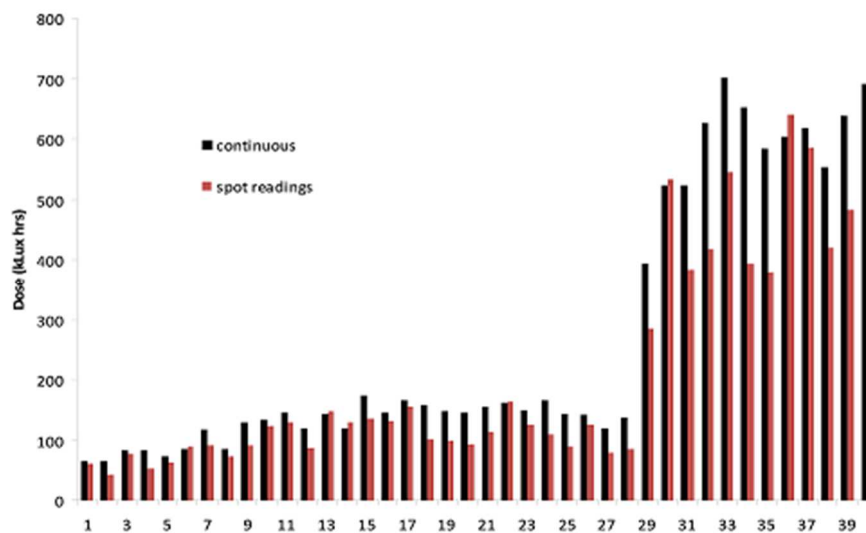
FIG. 2 - Doses from daily readings.

data files from six English Heritage properties were examined. Annual lux doses were calculated from the hourly data. The data was then reduced such that readings from 9am, 12am and 3pm only were used to generate the annual exposure. The calculated doses are shown in FIG. 2.

As can be seen, the spot readings differ significantly from the continuous doses, by up to 36%. In most instances (85%) they are lower and frequently much lower, which would give a falsely reassuring estimate of the light exposure.

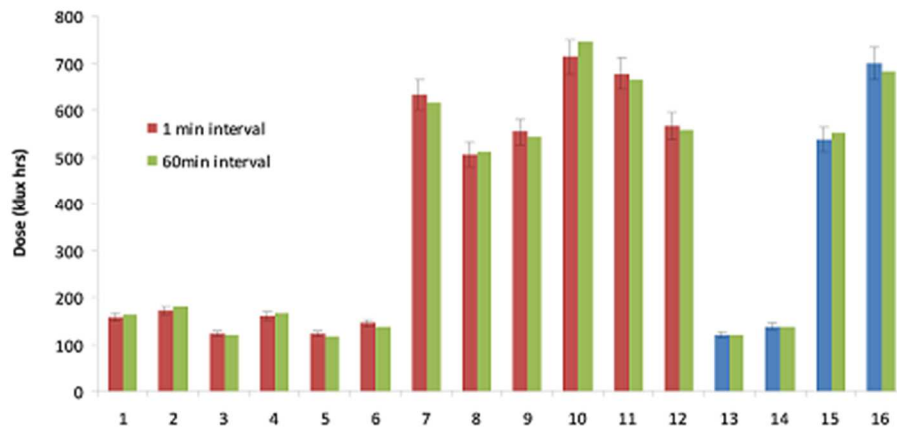
FIG. 3 - Doses from collecting data continuously, every minute and every hour.

The doses measured, using different intervals of the data and with the proportional dose monitor (FIG. 3), show less than 5% difference.

The frequency of measurement for automatic equipment appears to have little affect when above hourly. However, where blinds, shutters or curtains are used the relative timing of measurements can dramatically affect the dose, especially with limited opening hours. For example, if a room has the shutters open four hours a day, the measurement interval is hourly, on the hour and the shutters are opened at 12.01 and closed at 15.59, the dose will be underestimated by almost 50%.

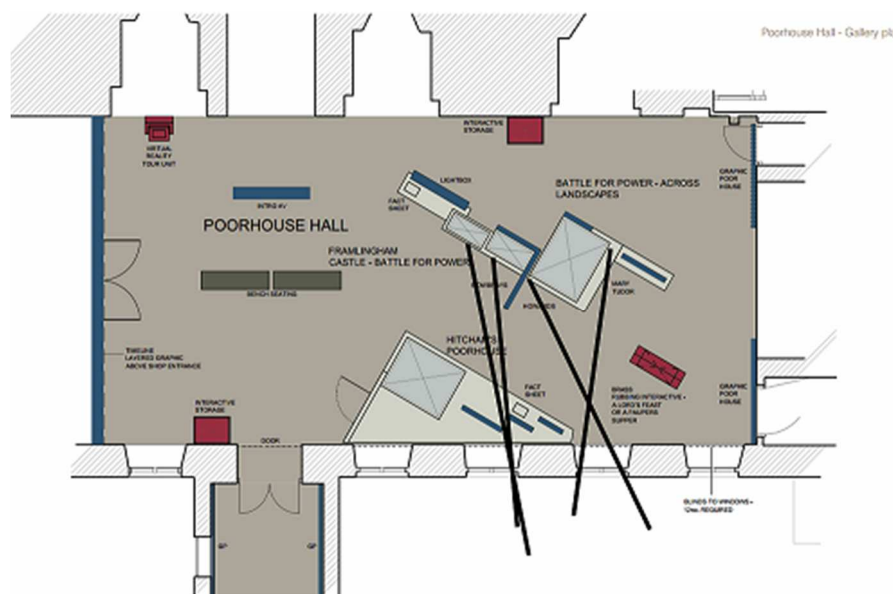
FIG. 4 - Framlingham.

Within English Heritage's estate, many historic properties now contain showcases. Careful design is required to ensure adequate showcase performance environmentally. In such situations, the room environments are frequently far from ideal, and showcases are often required to perform significant environmental remediation for safe display of their contents. At St Peters church, the surface temperature of archaeological bone displayed in showcases under stained glass windows found to have significant daily increases with predicted decreases in surface RH, within 2% of damaging levels (Thickett, 2008). This emphasizes the care needed with such situations. The intrinsic nature of historic properties can limit installation of light control. The stained glass could not have films adhered to it, the window framing was architecturally important, so blinds could not be fitted, and the light filtering through the stained glass was thought an essential component of the interior. Simple geometry can indicate when direct sunlight can fall on showcases, FIG. 4. As described previously, mobile apps can dramatically reduce the time needed for calculations.

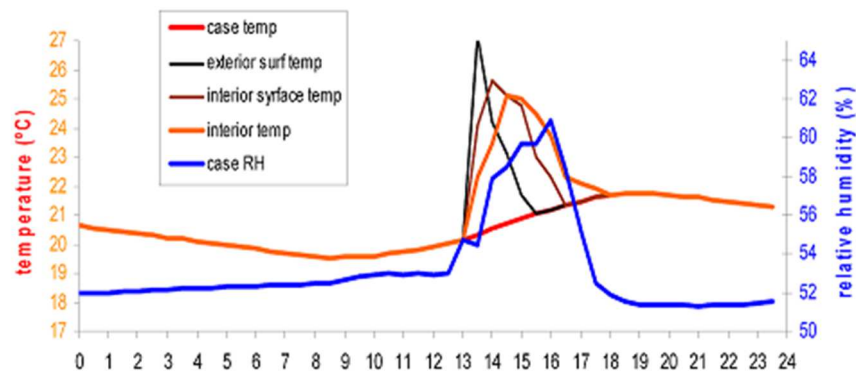
FIG. 5 - Kenilworth.

Although visible light was kept below 200lux, it was suspected that infrared emission from the heated blind was heating the dark brown plinth. The surface temperature was measured on the outside and inside of the plinth using Pt 100 sensors and a SR007 datalogger, and the internal air temperature inside the plinth was monitored with a Meaco transmitter. FIG. 5 shows a 24-hour period with the effect observed.

As can be seen, the exterior surface temperature of the plinth rises sharply around one pm. The interior surface temperature follows this increase more slowly and is heated for longer. The air temperature inside the plinth rises by 3°C and the RH in the case rises. The problem was solved by adding two fans to the plinth casing to ensure sufficient air-flow to remove the heat swiftly. Opening the view from the window with the mesh did not impact on the case performance with the fans running.

The majority of the cases easily met the loan specifications. One showcase initially showed short-lived RH peaks between 2 and 4 p.m. on most days, taking it out of specification for the loan object in it. No obvious temperature perturbation was associated with these RH changes. Sunlight had been observed to strike the plinth containing the Miniclimate unit at around this time in the afternoon during installation, before the blinds were lowered.

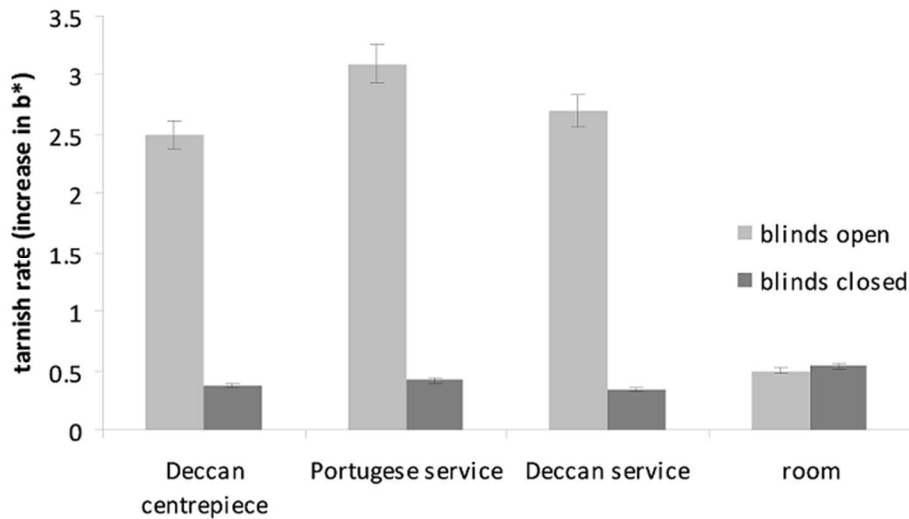
FIG. 5 – Silver tarnish.

relatively expensive to achieve. FIG. 6 and 7 show the silver tarnish rate and hydrogen sulfide concentration in showcases, between windows for 30 day periods under the old regime, with the blinds raised and the new regime using the light plan.

As can be seen, the hydrogen sulfide and tarnish rates are significantly higher when the showcases are exposed to UV filtered sunlight. The hydrogen sulfide and tarnish rates are similar in the room over the two periods. To further investigate small samples of the blue fabric were taken from areas exposed to light and those under card labels. The

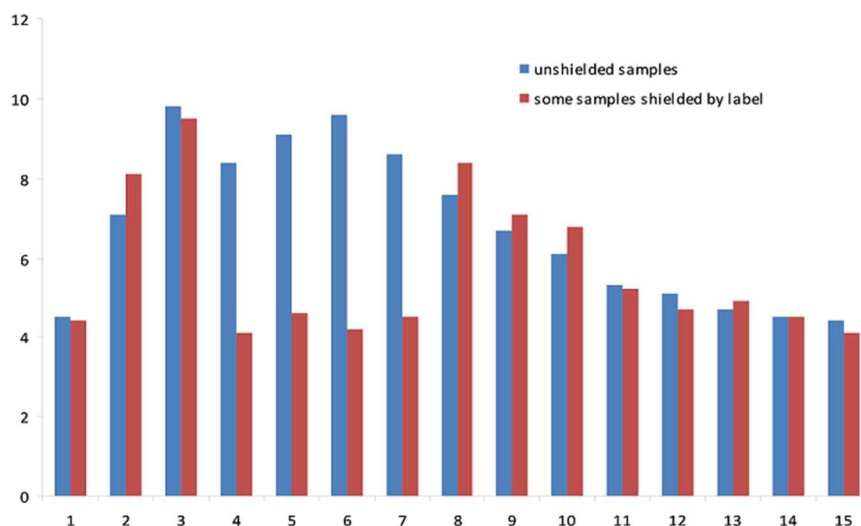
FIG. 7 - Cysteic acid area.

samples were analysed with Fourier transform infra-red spectroscopy and the area of the cysteic acid peak in the second derivative at 1046cm^{-1} determined as a measure of wool degradation (Odlyha et al., 2007). Results are shown in FIG. 7.

Points 2-11 experience sunlight, whilst points 1 is shielded by the case frame and points 4-7 are under a label. The unexposed wool is significantly less chemically degraded.
